Research Article

Earthquake Failure of Buildings with Overhangs

Earthquake,
Overhangs,
Turkish Building
Earthquake Code,
Torsional irregularity,
Structural irregularity.

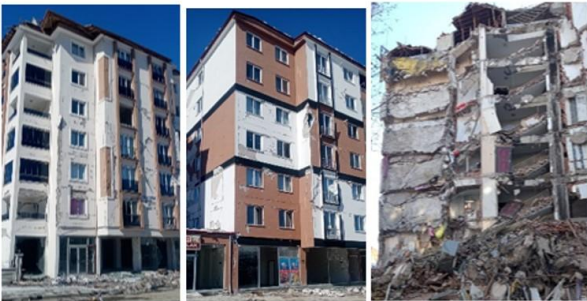
Figure 3. Overhang buildings in Malatya after on February 6, 2023, Kahramanmaraş earthquake

In almost all buildings in Turkey, the upper floors of the ground floors are designed as overhangs. Open or closed overhangs cause differences in mass distribution between storeys and eccentricity between gravity and rigidity center. In the latest Kahramanmaraş earthquake on February 6, 2023 with a magnitude of 7.7 and 7.6, various buildings with overhangs expose to destroying effects of the earthquake. They were heavily damaged or destroyed (Figure 3-4).

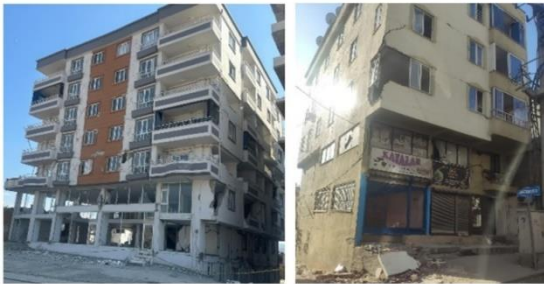
Figure 4. Overhang buildings in Hatay after on February 6, 2023, Kahramanmaraş earthquake
